Shielding Effectiveness Test Report for a TI-Shield™ Enclosure

ARL-MR-224 July 1995

Shielding effectiveness, TI-Shield™, IEEE-STD-299-1991, MIL-STD-907B

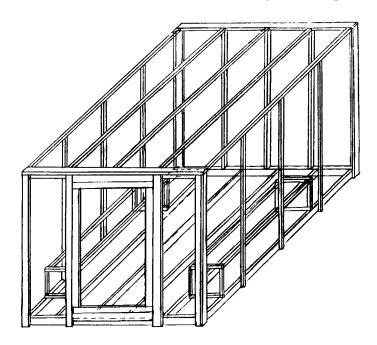
Figure 1. Framing structure for HSS mockup.

Figure 1 is a sketch of the wood structure (8 ft 1×6.8 ft $w \times 5.3$ ft h) used for the HSS mockup. We built the shelter 8 ft long so that standard lengths of wood could be used (the HSS is actually 8.5 ft long). This 6-in.-shorter shel-

ter will not affect the EM field attenuation measurements, since the test frequencies chosen are not near the fundamental cavity resonance. The mockup did not include the inside compartment in the front of the shelter, normally used to enclose the generator unit; its absence will not affect the EM field-attenuation measurements of the shelter's shielding material. The inside compartments for the wheel wells were included in the mockup (fig. 1).

We glued the entire frame structure together so that temporary metal fasteners could be removed and would not affect the EM measurements. The mockup was made from 1/4-in. plywood except the floor, which was made of 1/2-in. plywood. The interior (including the wheel wells) was then covered with 1/4-in. particle board that had TI-ShieldTM bonded to it. This resulted in 1/2-in.-thick walls and ceiling and a 3/4-in.-thick floor. Gaven Industries installed the particle board and soldered the seams using standard techniques. Seams were overlapped at least 1 in. and continuously soldered. The TI-ShieldTM panels were glued to the mockup so that temporary metal screws could be removed. The holes left by the temporary fasteners were covered with TI-ShieldTM patches and soldered, as were the triple corners (i.e., corners which include the floor or ceiling).

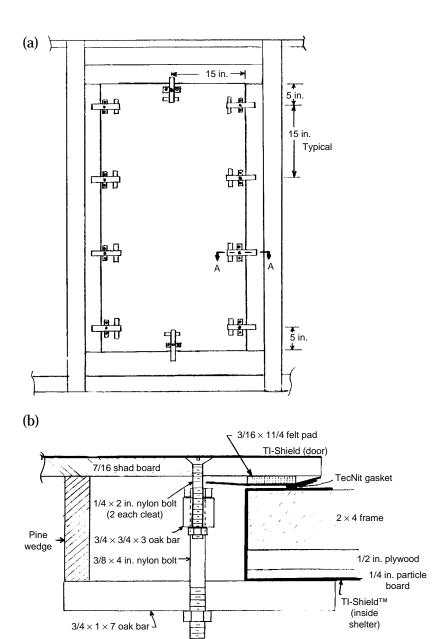
Figure 2. Door cleat: (a) locations and (b) detail.

A plywood panel was covered with TI-ShieldTM and used as a door. Non-metallic fasteners were designed to hold the door in eight places (fig. 2(a)). The cleat arrangement using nonconductive bolts and spacer blocks is shown in figure 2(b). The door panel was sized so that there would be at least a 2-in. overlap of shielding material around the door perimeter. A wire-mesh gasket was installed between the door and shelter wall to provide more uniform contact between the eight cleats (fig. 2(b)). The shimmed spacer blocks are adjusted to provide high-pressure contact. The resulting door arrangement, though not as good as an rf fingerstock door, could be adjusted to provide reasonably uniform electrical contact.

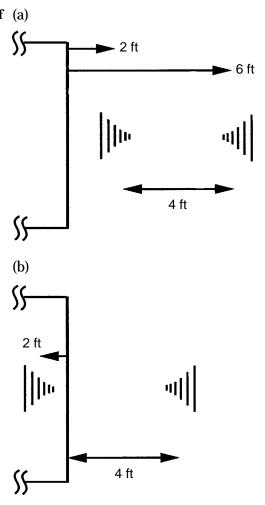
Figure 3. Top views of (a)
(a) mid-range
calibration procedure
(not to scale) and
(b) mid-range
measurement
procedure (not to
scale.)

The test configuration for the mid-range free-field calibration (fig. 3(a)), is more complicated. The distances specified in IEEE Std 299-1991 are modified to account for the larger antennas (roughly 2 ft in length) used in these tests. The center of the receive antenna is located 2 ft from the outside shelter wall, while the center of the transmit antenna is located 6 ft from this wall. The antenna separation (center to center) for calibration is then 4 ft (1.3 m), and the recommended scanning procedure is used. The antenna separations are consistent with IEEE Std 299-1991; however, the length of the longest LP elements violates the electrically small antenna length (one-eighth wavelength) specified to avoid variations in the antenna input impedance owing to the shield proximity. The recommended calibration procedures were used in addition to a true free-space calibration (i.e., in the absence of the shelter). The variations observed during these calibration procedures were 1 to 3 dB.

The mid-range measurement procedure is consistent with IEEE Std 299-1991, but the physical size of the LP antennas required the distances shown in figure 3(b). Each TP was tested using both polarizations of the matched antennas and the recommended scanning technique. In the scanning procedure the transmit antenna remained at a fixed polarization while the receive antenna was displaced and rotated. The largest reading was recorded for each TP at each frequency and polarization. This measurement (the minimum SE) was typically 2 to 3 dB larger and was observed near the solder locations.

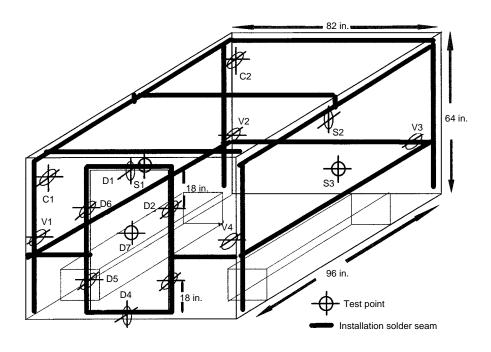
Figure 4. Test point and seam locations.

The preliminary scanning measurements recommended in IEEE Std 299-1991 were conducted at 20 MHz, which is much less than F_r , and at 350 MHz, which is much greater than F_r . The results indicated no significant problem areas except the door. Test points near the door showed SE reductions of several decibels, which depended on the pressure applied to the door's contact points. Since the HSS mockup has no other penetrations, the preliminary measurements indicated that all seams had been adequately soldered. The nonlinearity tests recommended in IEEE Std 299-1991 were not possible because of an insufficient measurement dynamic range. However, since the magnetic material is sandwiched between Cu sheets, no saturation effects would be expected at the field intensity levels used for testing [4].

The data indicate that the H-field SE (neglecting door leakage) is limited to about 70 dB at 20 kHz by this H-field diffusion through the nonmagnetic solder joints. This limiting effect can be somewhat improved by using fewer seams, a larger overlap, different solder, etc, but the H-field diffusion through the seams is expected to be greater than that through the TI-ShieldTM material at frequencies below about 100 kHz. The measured data indicate that a TI-ShieldTM structure can readily meet the EM shielding requirements of MIL-STD-907B, MIL-STD-188-125 [12], or the National Security Agency Specification No. 65-6 [13].
